# Engineering Failure Analysis

## Failure analysis of a high pressure natural gas pipe under split tee by computer simulations and metallurgical assessment

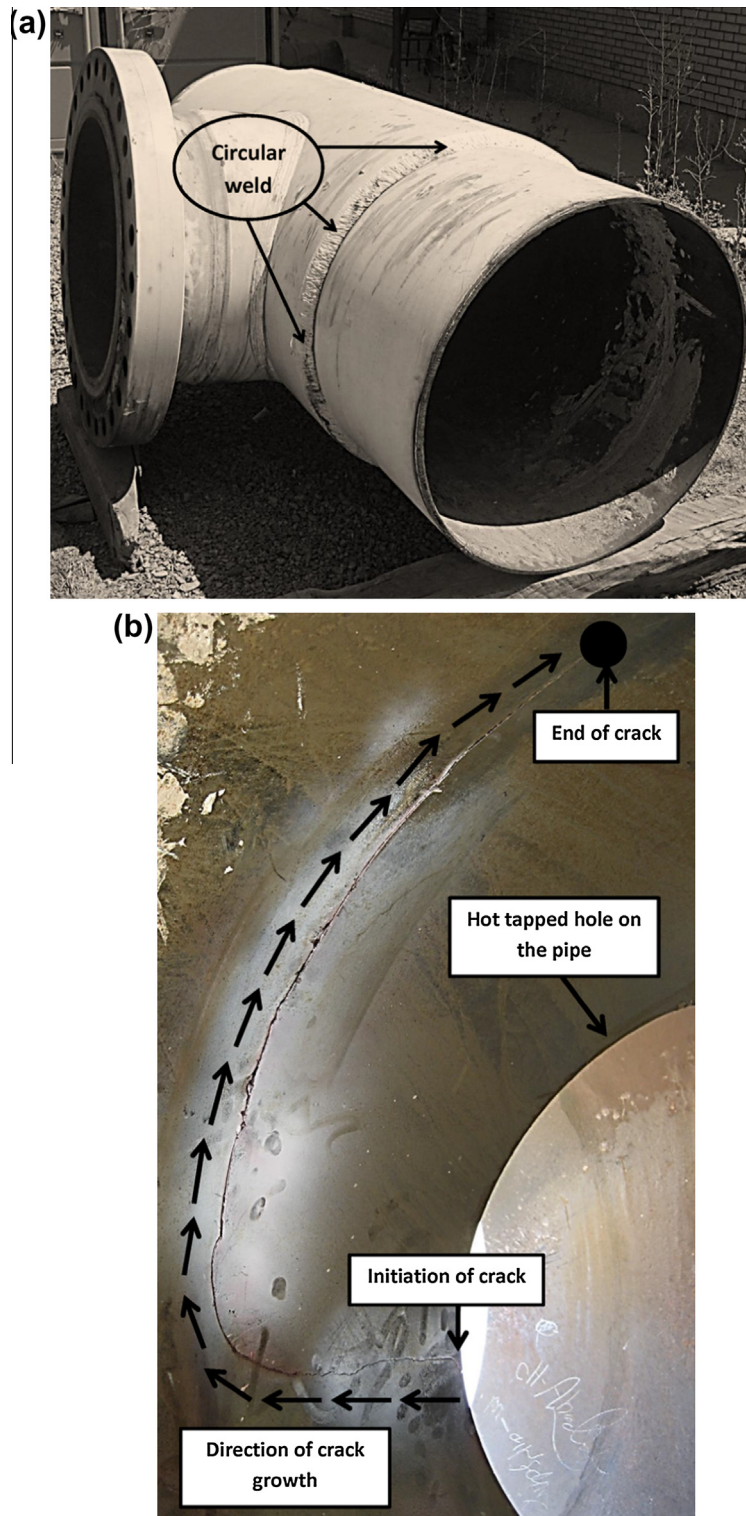
Fig. 1. (a) Front view of the damaged split tee and (b) crack inside the pipe under the split tee.

Fig. 1 demonstrates the damaged pipe and split tee after removing from the site and the crack inside the pipe. The crack has initiated from a point on the hot tapped hole and has grown in longitudinal direction, until arrested by the circular welds. In fact, by approaching the position of the weld, the crack changed its direction upward in a circular path.

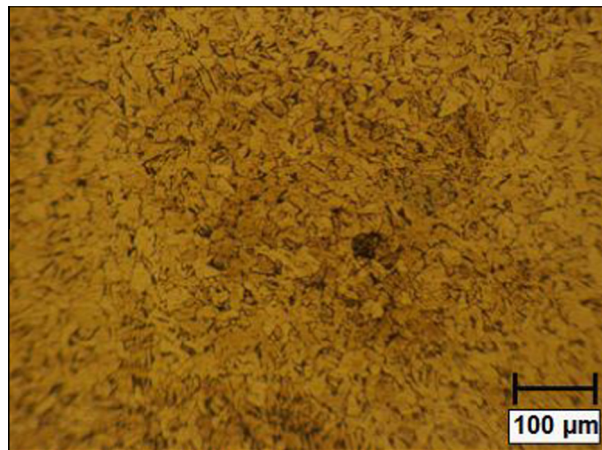
Fig. 4. Typical optical micrograph of the cracked pipe material.

Standard metallography techniques were employed to study the microstructure of the test pieces. Fig. 4 shows a typical optical micrograph of the pipe material; the structure shows a fine, equiaxed two phase steel consisting of a ferritic matrix with embedded pearlite as dark regions.

Voids and microcracks can nucleate at the ferrite–pearlite interface close to the localized plastic deformation zone, especially for elongated ferrite and pearlite grains. In fact, the elongated ferrite and pearlite can help in nucleation of narrow, stretched void and microcracks. However, the equiaxed pearlite grains also consist of lamellar cementite in a ferrite matrix. It is well known that, this type of microstructure can be subject to a new source of void and microcrack nucleation during plastic deformation under compressive loading [8]. However, neither void nor microcrack was observed in the optical micrographs of the pearlite grains. Thus, it can be stated that the failure in the present work, is not directly attributed to the microstructure of the pipe material.

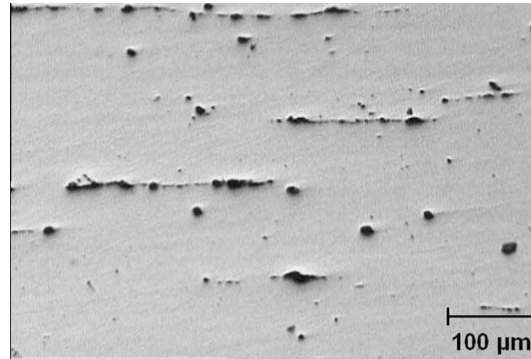
Fig. 5. Distribution of inclusions in the cracked pipe material.

Several specimens were cut in longitudinal direction of the pipe wall, near the crack and far from that Fig. 5 illustrates an optical micrograph of the as-polished sample showing many dark regions within the microstructure; identification of these regions by EDS analysis was carried out and it was found that they were composed of sulfide and alumina inclusions (Figs. 6 and 7). Inclusions, second phase particles and grain boundaries are known as the susceptible sites for void nucleation and initiation of ductile failure. Many researchers have found that inclusions serve as void nucleation sites under compressive loads [8–13]. For this reason, the inclusion content should not exceed the specified limit for the material. In addition, the

inclusion size is very important because large inclusions are the most harmful to the mechanical properties of the components. It is evident in Fig. 5 that a large number of inclusions were embedded in the pipe material as parallel arrays, thin but rather long. Although the inclusions were expected as spherical particles in API steel, some elongated shapes appear as parallel rows in the rolling direction. Chemical analysis of points P1 (located on a long inclusion inside the crack) and P2 (within the steel matrix) revealed high percentages of aluminum, manganese and sulfur, confirming alumina and MnS inclusions. As a general rule, such elongated inclusions are considered to be detrimental to the toughness of the material.

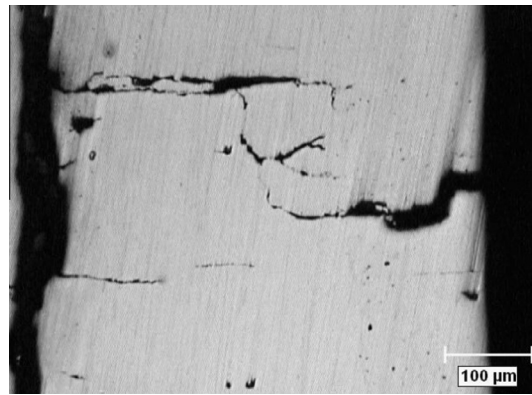
Fig. 8. Typical microcracks originated from the major crack along the inclusions.

Fig. 8 shows several microcracks in the longitudinal direction of the pipe wall, connected to the major crack through the thickness. Careful examination of a sample, prepared at the vicinity of the major crack, indicated some microcracks originated from that along the inclusions that serve as a means of crack path. Elongated type inclusions might act as preferential sites for propagation of pre-existing cracks [10–12]. An inclusion can easily serve as a stress concentration site because of the

discontinuous nature and the lack of compatibility with the matrix material. Further examination of Figs. 5 and 8 demonstrate that inclusions are non-uniformly distributed within the steel microstructure, enhancing the formation of voids and a path for easy growth of microcracks. Nevertheless, there was not sufficient evidence to confirm that inclusions were the major cause of pipe failure.

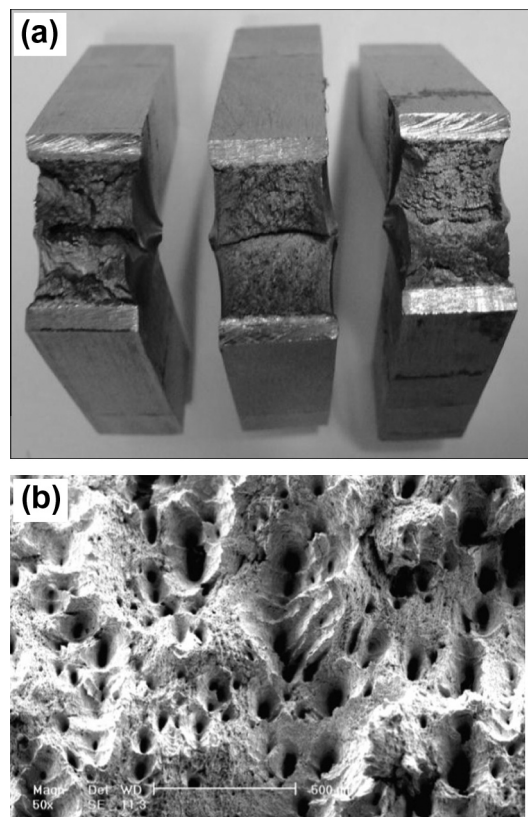
Fig. 9. (a) Impact test samples and (b) a typical fracture surface.

Fractography was carried out using scanning electron microscopy on both the crack faces and the fracture surface of the samples after impact testing. Typical fractographs of impact samples, presented in Fig. 9a, indicates that fracture has a ductile morphology. At low temperatures, ductile fracture usually involves the nucleation, growth and coalescence of voids in a plastically deforming material. Void nucleation normally occurs in the presence of inclusions and is caused by debonding of the inclusion from the surrounding material [10]. In fact, due to the flow of matrix material around the inclusions, the big spherical inclusions rotate. This leads to debonding at the interface between the inclusion and the matrix material. Thus, the

inclusions act as stress risers and can support void nucleation, growth, and coalescence, leading to ductile fracture mechanism. The oval shape of some of the voids in Fig. 9b is consistent with the elongated inclusions observed in the optical micrographs of the pipe material.

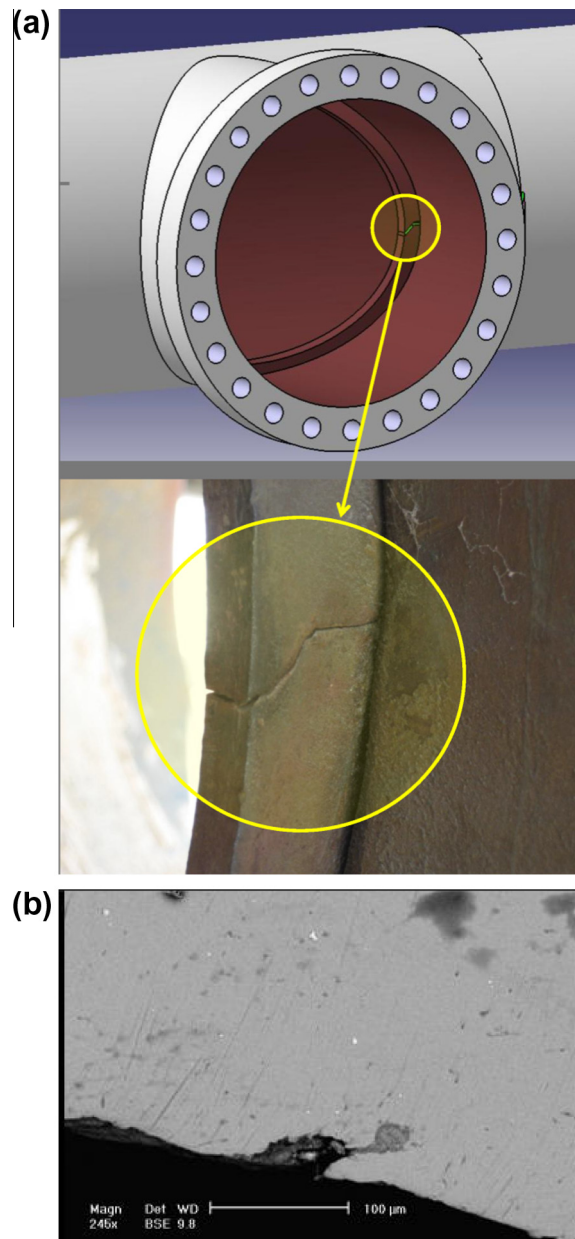
**Fig. 10.** A dent found inside the hot tapped hole where the crack was initiated; (a) approximate position of the dent on the oval hole and (b) SEM micrograph of a typical dent.

The surface of the hot tapped hole was examined for any indication of surface irregularities that might exert notch effect, producing stress concentration. Although, after many years from the failure time, the pressure in the pipe caused erosion of sharp edges and corrosion products covered all exposed surfaces, a type of damage was identified as a dent inside the hot tapped hole as shown in Fig. 10. Mechanical damage could have been occurred from the equipment during hot tapping process. Heavy oxide deposits on the crack surface proved severe corrosion of the fractured faces during a long time exposure after cracking. Further examination of the failed pipe confirmed that the main crack has initiated from the dent with its notch effect and progressed along the pipe during operation.

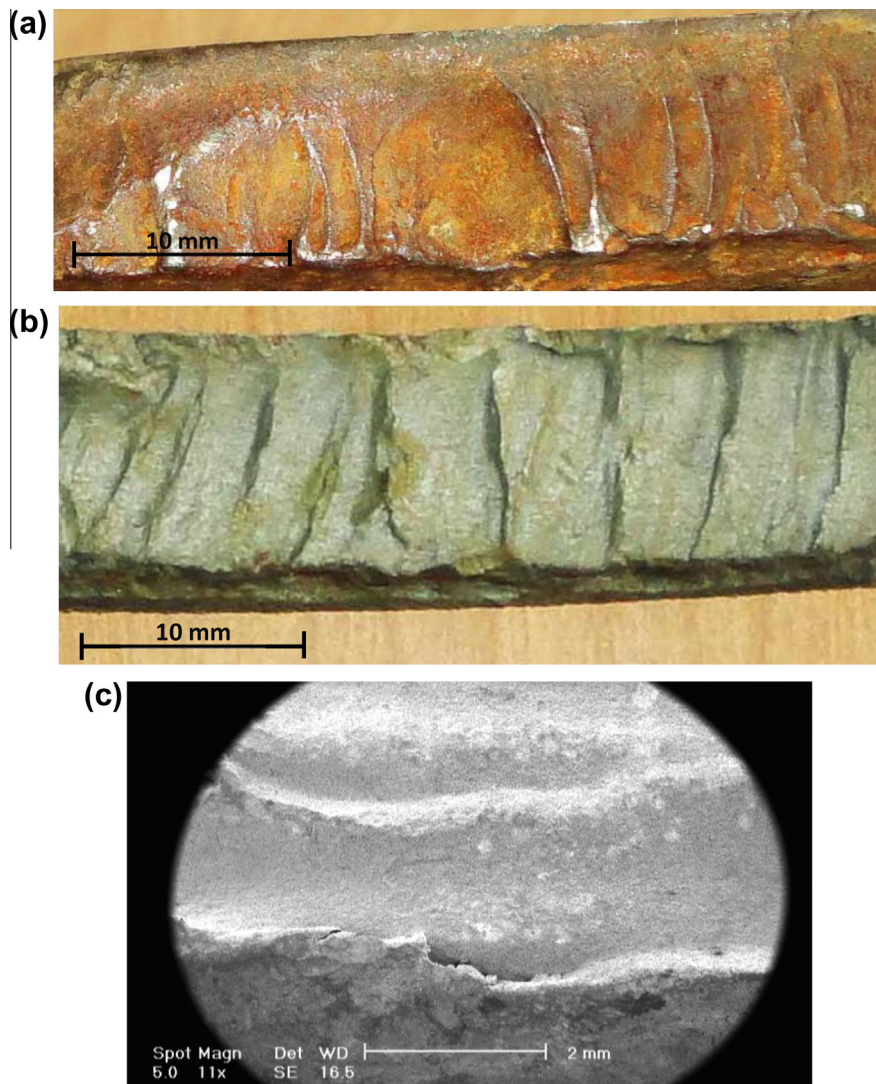
**Fig. 11.** Macrographs showing a typical zone of the crack face; (a) fracture surface covered with corrosion products, (b) fracture surface after cleaning in acid solution and (c) SEM micrograph of two adjacent ridges on the fracture surface.

Fig. 11 shows a typical zone of the crack faces prepared from the pipe wall thickness before and after acid cleaning. The fracture surface in Fig. 11a, covered with a layer of corrosion products, is composed of irregular ridges. After thorough cleaning of the surface in acid solution, the structure of the crack surface indicated rather uniform ridges spaced 2–4 mm apart from one another, Fig. 11b. Such a poorly formed sawtooth profile can be attributed to a fatigue fracture; the fracture surface could have been resulted from combined stage I and stage II fatigue crack propagation [14]. Further examination of the crack faces revealed a steplike appearance indicative of discontinuous growth; these are expected to occur under conditions of high through-thickness strains in structural steels. The steps appear as macroscopic beach marks, or clamshell markings, either radiate away from the crack origin or lie as parallel ridges. These are a special form of progression mark commonly associated with low cycle fatigue. When the propagation zone was examined by SEM, no beach mark was resolved on the fracture surface that was prepared by acid cleaning, instead, a featureless region was observed between the adjacent ridges, Fig. 11c. Nevertheless, based on the macroscopic observations of the fracture surface, it may be concluded that a fatigue mechanism has been involved in the process of crack growth during service life of the pipe.

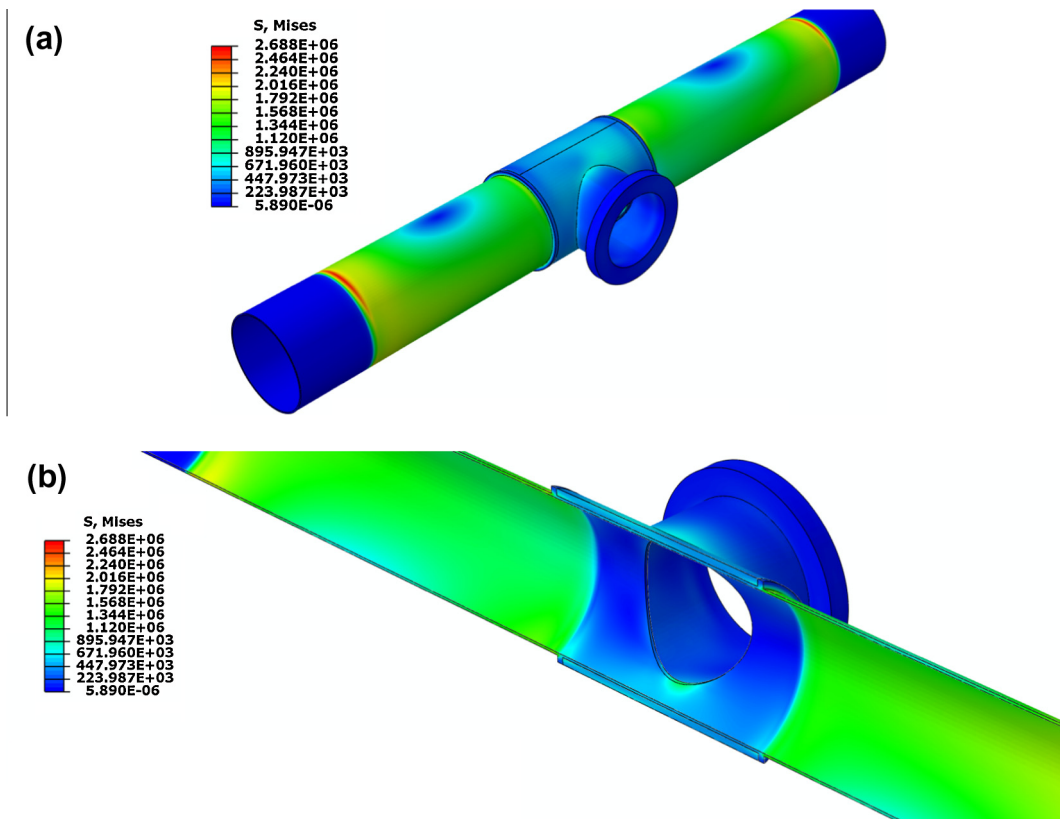
Fig. 14. Stress distribution due to gravity (a) front view and (b) cut of the back view.

The split tee is rather a heavy part. In order to consider the effect of the weight of pipe and split tee on stress distribution, the gravity was set as the external force and the stresses were taken into consideration. Fig. 14 shows the results where the unit indicated for stress contour is Pascal. The results indicate that the stress exerted from the weight of split tee and pipe are

low and may be neglected in comparison with the stresses developed due to the inner gas pressure. The maximum bending moment occurs at positions of the longest length and this happens near the supports. Accordingly, the highest values of Von-Mises stresses are positioned in this area. Considering Fig. 14b, one may note that the stresses due to parts weight, on the area that the crack was propagated are very low and, consequently, the weight of pipe and split tee cannot be responsible for this failure.

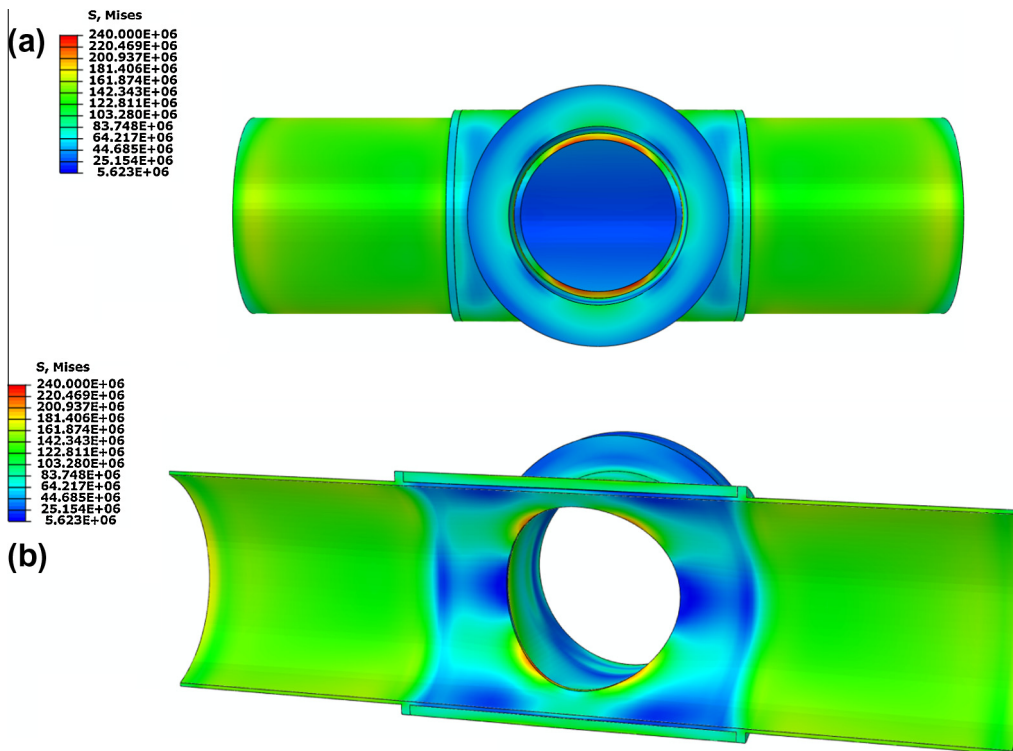
Fig. 15. Stress distribution due to the gas pressure; (a) front view and (b) cut of the back view.

Fig. 15 demonstrates the results of stress distribution caused by the gas pressure inside the pipe; the highest value of stress is 240 MPa which is well below the yield strength of pipe material. In addition, the areas of high stress are not positioned on the regions that the crack has grown. Therefore, if the gas pressure was responsible for crack propagation, the crack should have initiated and progressed somewhere closer to the regions of high stress values.

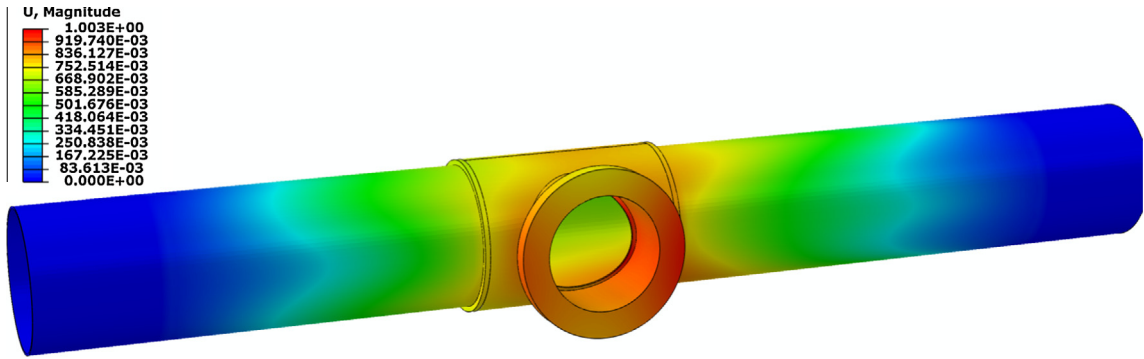
Fig. 16. The first mode shape of the pipe and split tee set.

Table 3 shows the first five natural frequencies of the whole system and Fig. 16 presents the first mode shape of the pipe and split tee. It can be seen that the maximum displacement is located exactly where the crack was initiated. Obviously, the maximum displacement would lead to maximum stress in this zone. The first natural frequency of the system is 69 Hz that is a rather low frequency, especially for a gas pipeline system under vibration. But, it must be noticed that in gas pipeline sys-

tems connected to the valves or other sources of vibration, the excitation frequency is generally below 100 Hz [9]. Hence, modal analysis proved that the system has not been sufficiently stiff with a low natural frequency for gas pipeline. Moreover, the maximum displacement and, consequently, the peak stress were situated in the area where the crack was initiated.

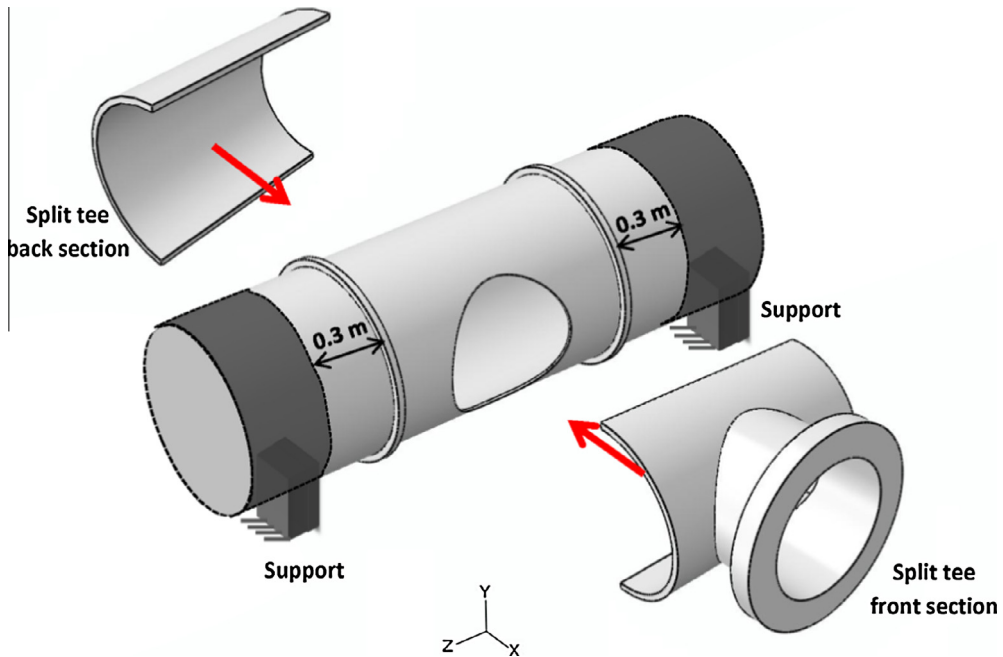
Fig. 17. The new position for the supports (0.3 m far from split tee).

It can be concluded that if the position of the supports had a shorter distance to the split tee (e.g., 0.3 m compared to previous value as shown in Fig. 13), the first natural frequency would have been more than twice the previous situation (Fig. 17). Under such condition, the natural frequencies (Table 4) would have been in excess of 100 Hz and, consequently, less energy would be absorbed by the system, the level of dynamic stresses would be decreased; the initiation and propagation of crack along the pipe could be inhibited.
