# Engineering Failure Analysis

## Failure analysis of a high pressure natural gas pipe under split tee by computer simulations and metallurgical assessment

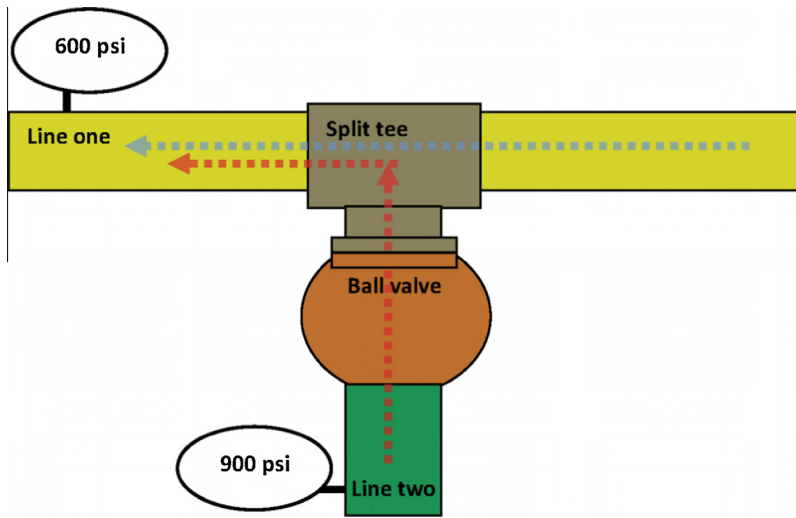
Fig. 2. Schematic of the split tee under work conditions.

Fig. 2 shows a schematic of the split tee under working conditions. Line 1 is the principal gas pipeline while line 2 is only used in occasions to compensate the pressure drop in order to maintain the pressure of line one at a desired level. The amount of gas flow from line 2 to line 1 was controlled through a ball valve connected directly to the split tee. On average, the pressure is approximately 600 psi in line 1 and 900 psi in line 2. The valve was operated manually to ensure a pressure of 600 psi in line one. Due to the pressure drop of 900–600 psi and the energy loss by this ball valve, the valve was rigorously vibrating with a frequency range below 100 Hz. The connection between the two lines has been produced by hot tapping process, thereby, the ball valve was connected directly to the split tee.

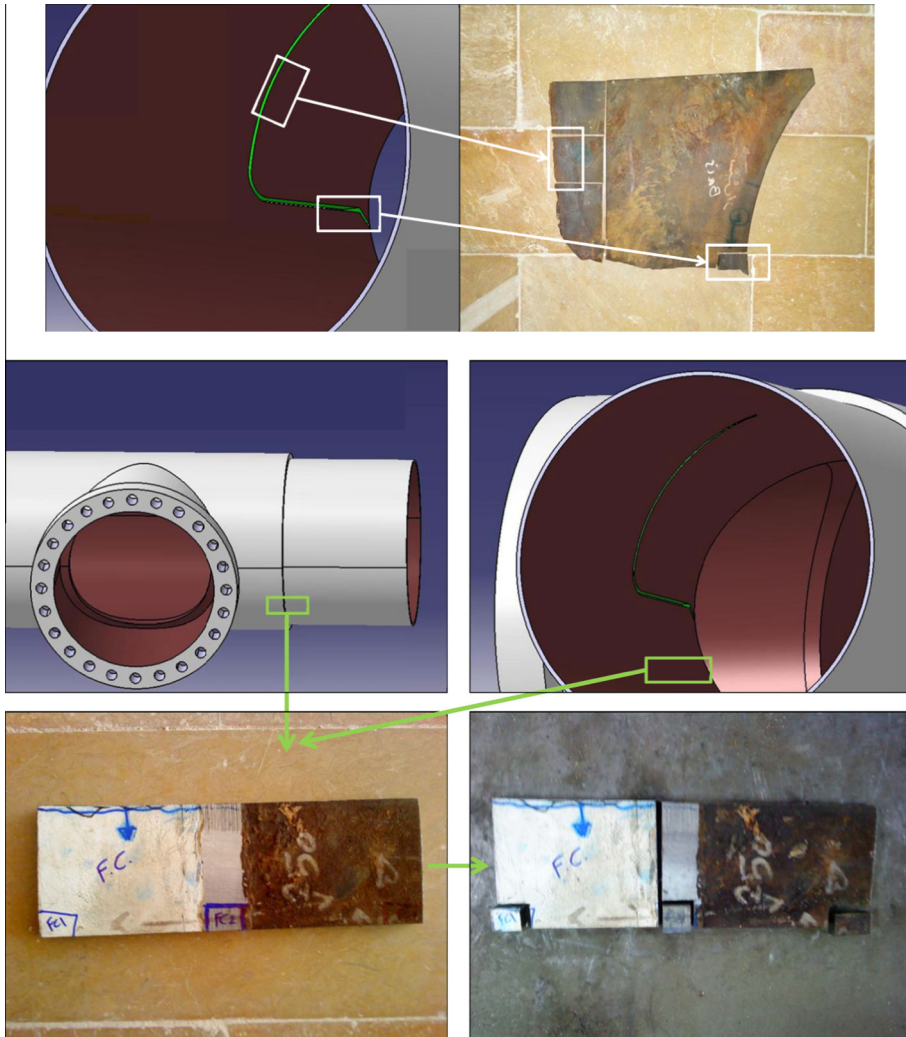
Fig. 3. Test samples prepared from the pipe material and their position on the failed pipe.

was noticed that the crack was growing through the thickness such that the pipe body was separated into two parts. Fig. 3 shows a schematic of the prepared samples and their position on the cracked pipe.

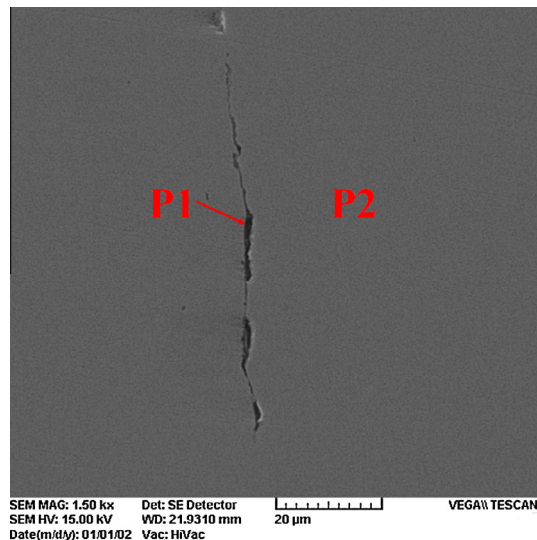
Fig. 6. Positions of spots for microanalysis by EDS; point P1 is located at the inclusion and point P2 is on steel matrix.

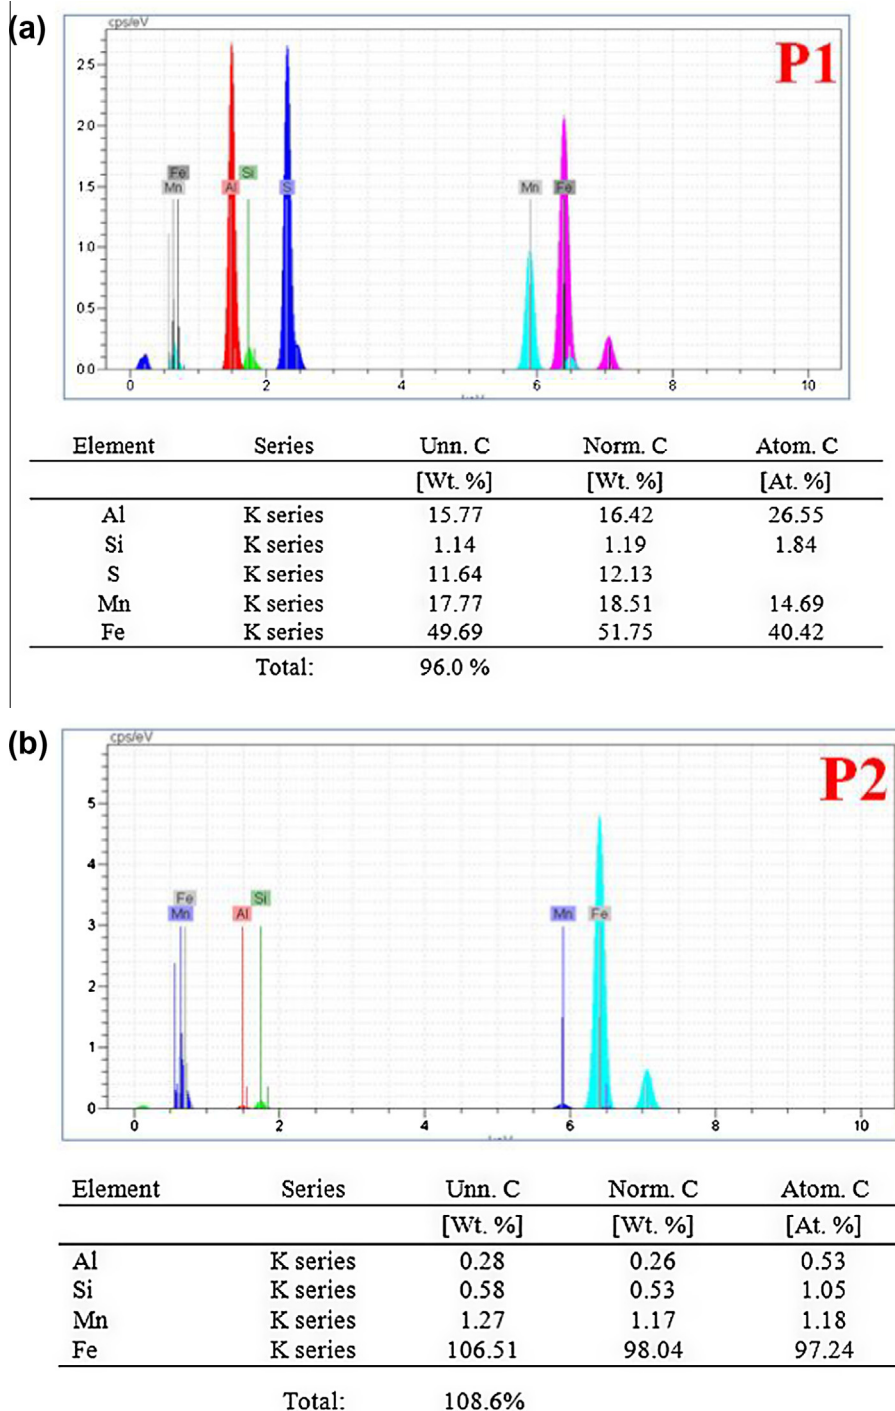
Fig. 7. Results of EDS analysis performed; (a) typical elongated inclusion (P1) and (b) steel matrix around the inclusion (P2).

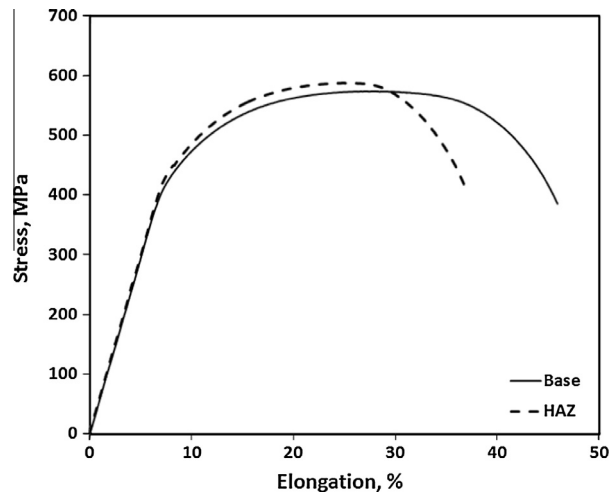
Fig. 12. Engineering stress–strain curves for the pipe material at two positions; base metal and heat affected zone.

Typical stress–strain curves obtained from the tensile tests are shown in Fig. 12. The graphs were essentially similar in strength level, but the sample machined from HAZ had lower elongation compared to that of the base metal. Nevertheless, both the HAZ and base metal elongations were within the standard range for X60 steel.

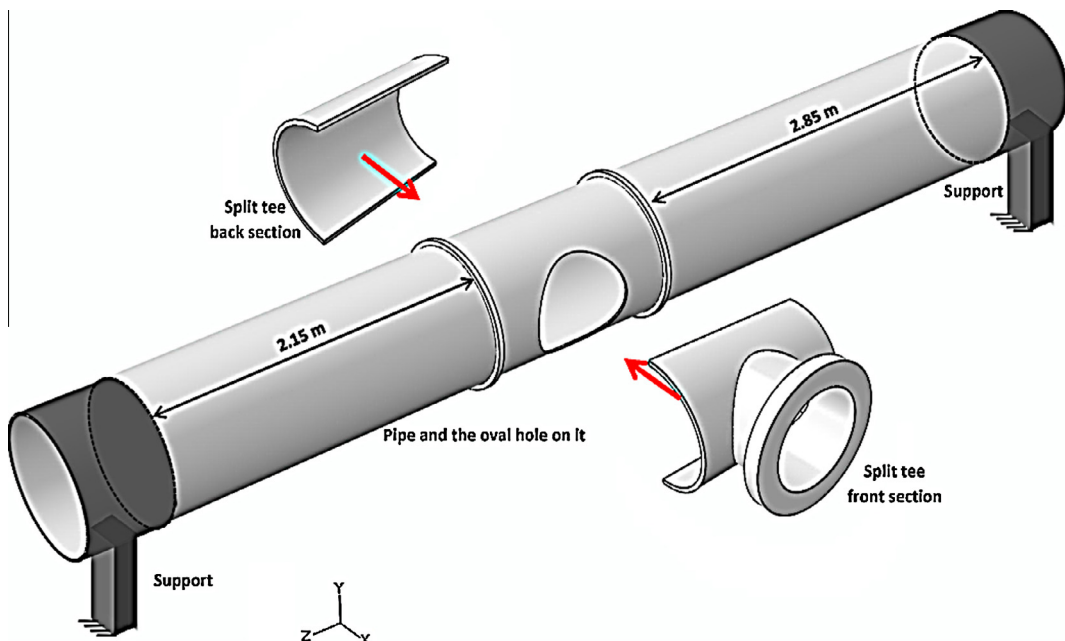
Fig. 13. Four major elements of the analysis; pipe, back section and front section of split tee and position of the supports.

The finite element static analysis was employed as a reliable technique for stress calculations. For a better clarification of the position of the supports and other parts of the failure system, Fig. 13 shows a schematic of four main elements; pipe, front section and back section of the installed split tee and the position of the supports.

It can be concluded that if the position of the supports had a shorter distance to the split tee (e.g., 0.3 m compared to previous value as shown in Fig. 13), the first natural frequency would have been more than twice the previous situation (Fig. 17). Under such condition, the natural frequencies (Table 4) would have been in excess of 100 Hz and, consequently, less energy would be absorbed by the system, the level of dynamic stresses would be decreased; the initiation and propagation of crack along the pipe could be inhibited.
